Piercy Creek Habitat Improvement Project completed

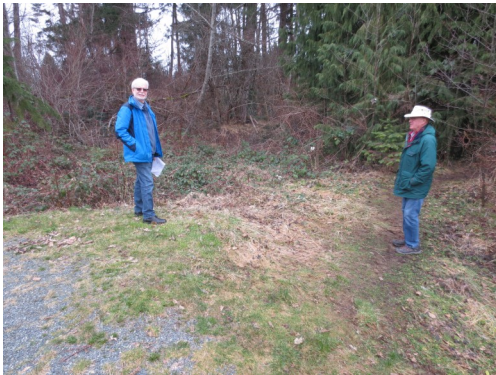
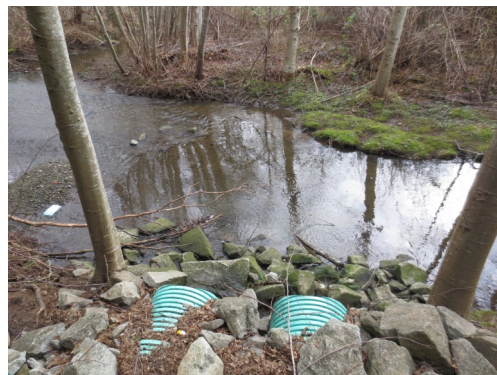
Before

For several years, the Millard Piercy Watershed Stewards raised concerns about creek and fish habitat being damaged by storm-water outlets leading directly into Piercy Creek at the south-eastern corner of Piercy Creek Estates. Severe creek bed and bank erosion occurred and, as a consequence, disturbance of Coho spawning gravel.

The outlet has been retracted from Piercy's bank and aligned with the natural bend of the creek. Also, Rip Rap was added to eliminate torrential discharge of storm water into Piercy Creek.
